TECHNICAL SERVICE BULLETIN

ACCESSORY BELT DRIVE SYSTEM

ACCESSORY BELT DRIVE SYSTEM HONDA

BULLETIN TSB_046_US

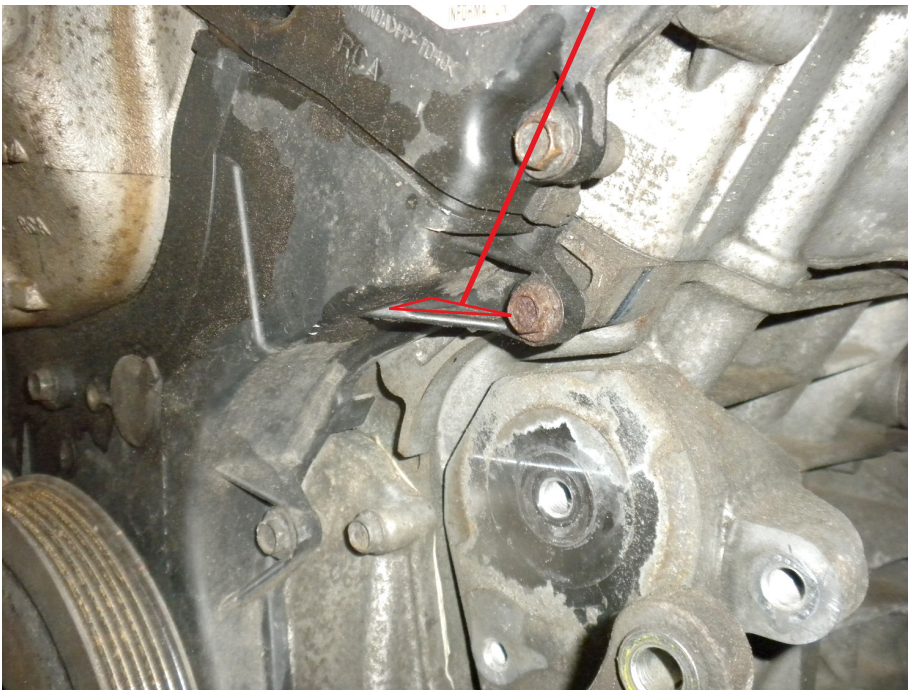
THIS AREA WILL NEED TO HAVE 3MM OF MATERIAL REMOVED.

IMPROPER INSTALLATION MAY RESULT IN A DAMAGED FRONT TIMING BELT COVER AND IMPROPER ACCESSORY BELT TRACKING, EVENTUALLY LEADING TO BELT FAILURE.

Particular V-6 applications described in Honda Bulletin 08-082 may require a small modification to the front timing cover during replacement of the accessory drive belt tensioner. (Gates part number 38332) The OE now provides an updated tensioner assembly which may cause interference with the front timing cover of some applications. Gates also offers the same, updated design as the OE. The small task is to remove approximately 3mm of plastic material from the front cover, allowing proper clearance.
