PROBLEM Solver™ BULLETIN

Alignment Adjustability Restrictions

1999-2007
General Motors Trucks

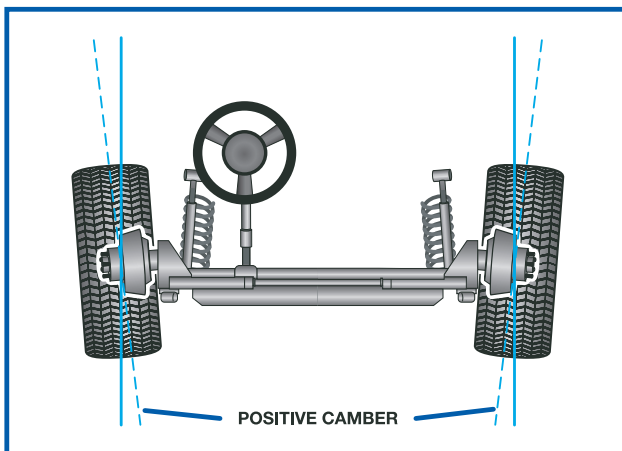
Alignment adjustability restrictions

- OE adjustments may not provide adequate range to obtain a proper alignment on late model Chevrolet and GMC light trucks.
- Excessive positive or negative camber will cause the vehicle to pull left or right and will create wear on the inside or outside edge of the tire.

MOOG® upper control arm offset bushings for camber and caster

- Provides an effective, low-cost means of obtaining more camber (and/or caster).
- Offers an additional 2 degrees of camber change.
- Used with factory cam adjuster, but allows greater range.
- Designed with OE-type material to maintain ride quality and service life.
- Fast and simple installation – made easier with the use of T40259, a bushing adapter specially designed to work with K6669 and K6670.
