CARDONE™ ProTech®

GM "W" Body Calipers Seized

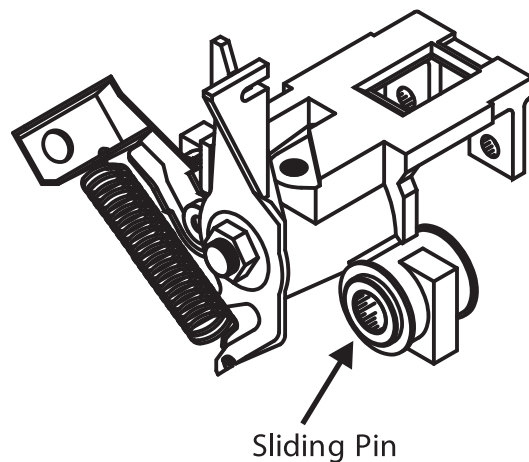
Problem Corrosion causing the slider pin to seize in the caliper.

Cause The use of dissimilar metals in the original design results in corrosion in the caliper slider pin bore, causing the slider pin to seize.

Solution CARDONE caliper part numbers 18-4295, 18-4296, 18-4327 and 18-4328 have a redesigned slider pin and a new dust boot. The redesigned pins allows more high temperature synthetic lubricant to be retained in the slider pin bore, preventing the pin from seizing.
