Overlooked Temporary Plugs Cause Leaks on Some GM Pumps

All Saginaw Power Steering Pumps with reservoir.

JDA0314 PT20-0013V

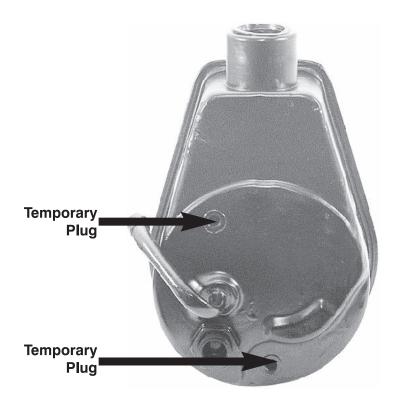
Unit leaks from plugs in reservoir after installation.

Temporary cap plugs not replaced by mounting bolts.

For most applications these holes will be closed by mounting bolts or studs. Holes not used for mounting should be plugged using the following sized bolts. For Standard thread pumps bolt size is $3/8 \times 16$. For metric threads us $10m \times 1.5 m$. Bolt length is 1/2 inch.
