GM EVO Power Steering Pump Doesn't Have Enough Ports

JDA2043 PT20-0019

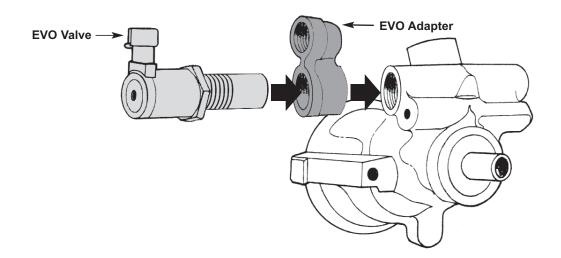
CARDONETM replacement pump has only one port and no pressure fitting. The original unit has two ports.

The extra port is actually a special adapter that is not supplied with the replacement unit. The adapter and EVO valve must be transferred to the replacement unit.

To transfer the valve and adapter, first unscrew the EVO valve. With the valve removed, apply side-to-side turning pressure to the adapter. The adapter should loosen. Slide adapter out of pump housing (see picture of separated components). Thoroughly clean the valve and adapter, then install in reverse order of removal. Be sure supplied piston and spring are installed in replacement unit before assembling adapter.
