CARDONE™ ProTech®

Erratic Steering Assist on GM Variable Effort Steering (VES) Vehicles

1997-1998 GM/GMC Sport Utilities (Astro, Express, Safari, Savanna)
1997-2001 GM/GMC Pickups (Silverado, Sierra)

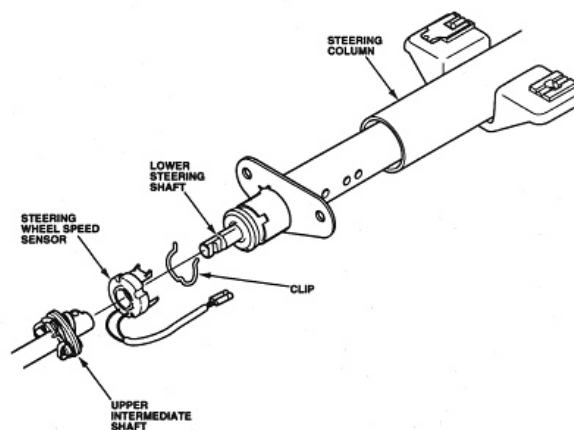
Sensor Test: If the steering wheel position sensor is bad, the vehicle ECM, in most cases, will detect this and set a Diagnostic Trouble Code (DTC). If no code is set, temporarily disconnect the sensor then see if erratic assist stops or assist returns. If operation returns to normal, perform tests on the sensor, wiring to ECM and the ECM. Please refer to the vehicle service manual for detailed sensor testing and repair procedures. The graphic below shows the typical sensor location on the steering column.

Verification of proper function of all these components should be performed before replacing any of these components.
