Clogged Power Steering Reservoir Filter – Toyota & Lexus

Application Toyota and Lexus vehicles with power steering.

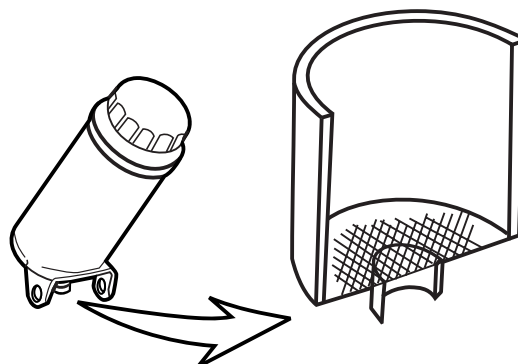
Cause Noise or reduced assist may be caused by restriction in the power steering fluid reservoir. Most Toyota/Lexus-style reservoirs have a filter screen at the bottom. Over a period of time this filter could get clogged causing the restriction of fluid.

Cut-away of a typical reservoir showing internal filter screen

Solution Replace any hose that shows signs of cracking or internal deterioration. Thoroughly flush the power steering system; then remove the reservoir for cleaning as follows:

1. Clean the exterior and interior of reservoir with new power steering fluid or suitable solvent.
2. Blow off the filter screen using pressurized air until restriction or clog is removed.
3. Using a flashlight, check to make sure that the filter screen is free of debris. **Note:** Contamination may be an indication of internal breakdown of hoses, which must be replaced before operating the vehicle. Failure to replace bad hoses could damage both the pump and steering unit.
4. Reinstall reservoir, referring to the service manual for tightening specs and bleeding procedures
