What You Might Be Missing with Your Cto Rack & Pinion Install

JDB3280 PT22-0006V

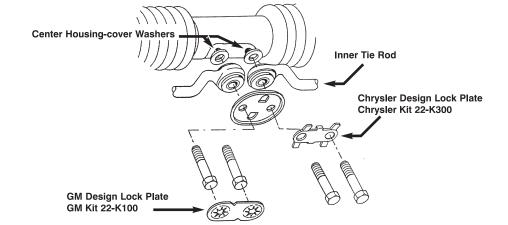
LOCKING PLATES DESIGNS ARE NOT INTERCHANGEABLE

Only use original design mounting hardware and fasteners when installing rack & pinions. Never omit mounting components and always install unit exactly to original specifications and procedures. Failure to install both center housing cover washers or to install the wrong locking plate will allow bolts to bottom in housing causing binding and damage to the unit. (Scan code to watch video tip). CARDONE Service Plus Rack & Pinion inner tie rod end repair kits for GM and Chrysler CTO units are now available. Each kit contains all the parts necessary to do the job right the first time (GM Kit 22-K100; Chrysler Kit 22-K300).
