CARDONE™ ProTech®

47-1377: Resetting Limit Switch

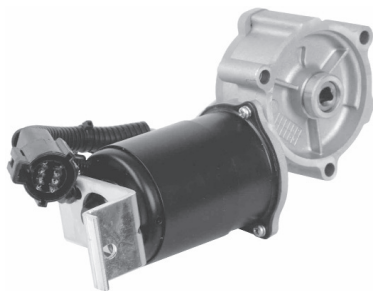
Typical Ford Motor

Ford applications require transfer of wire connector pins. Be sure to record pin location before removing the original unit.

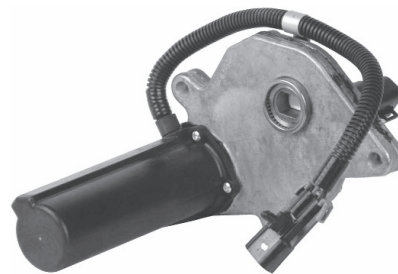
Typical GM Motor

Replacement motors for GM vehicles are supplied in 2-wheel drive position. If necessary, select or move transfer case into 2-wheel drive before installation of replacement motor. GM applications will require a scan tool to clear the codes from the transmission control module (refer to the vehicle service manual for correct tool and procedures).
