Difference between 58-147 and 58-320

Application G.M. Water Pumps - CARDONE[™] Part Numbers 58-147 and 58-320.

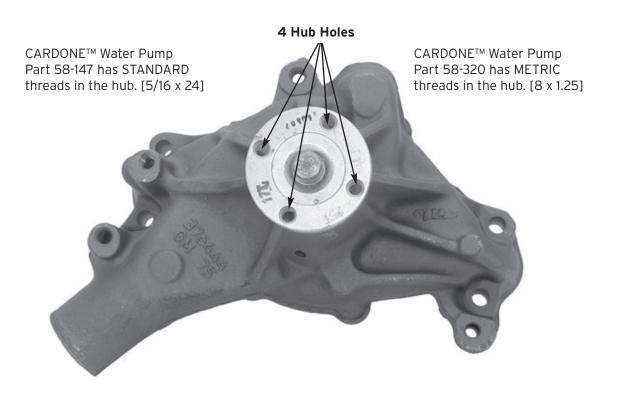
Problem The original pulley studs or bolts do not fit the replacement unit, causing cross-threaded or stripped hub bolt holes on replacement unit.

- **Cause** Use of incorrect studs in hub bolt holes or the wrong pump.
- **Solution** Verify the water pump application. The pumps are similar except for the tapped hub hole threads.
