## GM Power Steering Gear Pop or Crunch Noise

GM power steering gears: 27-6535, 6560, 7525, 7547, 7549, 7561, 7562, 7563, 7573 and 7583.

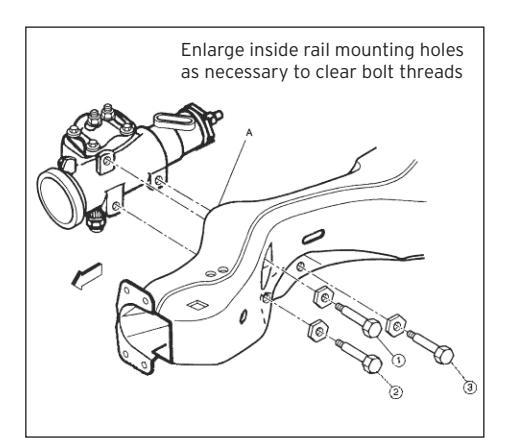
**Problem** Crunch and/or popping sound during low-speed turning.

**Cause** The lower control arm may be striking the steering knuckle during full-turntype maneuvers, causing the crunch sound. Slight movement between the steering gear attaching bolt threads and the frame rail inboard steering gear attaching holes may cause the popping sound.

**Popping sound:** Examine the frame rail inboard steering gear attaching holes for evidence of bolt thread contact. Enlarge inboard mounting holes that show contact only enough to allow the bolt threads to be free in the frame holes (use appropriate tools for the job). Reinstall the gear, but do not tighten bolts 1, 2 and 3 (see figure 1). Then perform the following steps:

- Start the vehicle and cycle the steering lock to lock several times, allowing the gear to reposition itself.
- 2. Torque attaching bolts (1, 2 and 3) to 70 ft. lbs. (95 Nm).
