TECHNICAL SERVICE BULLETIN

ACCESSORY BELT DRIVE SYSTEM

PREMATURE TENSIONER FAILURE DUE TO A/C COMPRESSOR SLUGGING

BULLETIN TSB_039_US

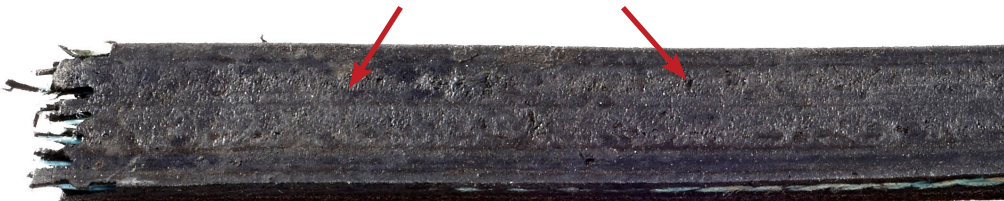
Evidence of overheating caused by compressor slugging.

Anytime unusual noises are heard emanating from the engine compartment, or poor performance from the A/C system is observed, the technician should thoroughly inspect the vehicle for compressor slugging. The most common indications of compressor slugging include damage to the tensioner stop as illustrated below, a broken serpentine belt, or a blown apart A/C compressor. A thorough examination of the transmission cooler lines should also be performed as damage could result from contact with the serpentine belt.

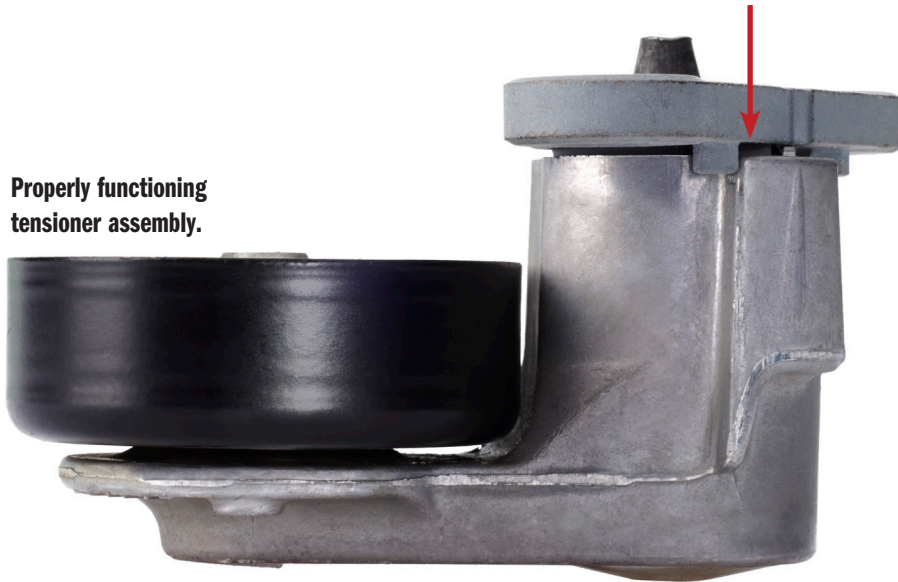
Tensioner stop with normal operation of tensioner.

Properly functioning tensioner assembly.
