CARDONE™ ProTech®

Overlooked Pressure Hose Seal Causes Power Steering Leaks

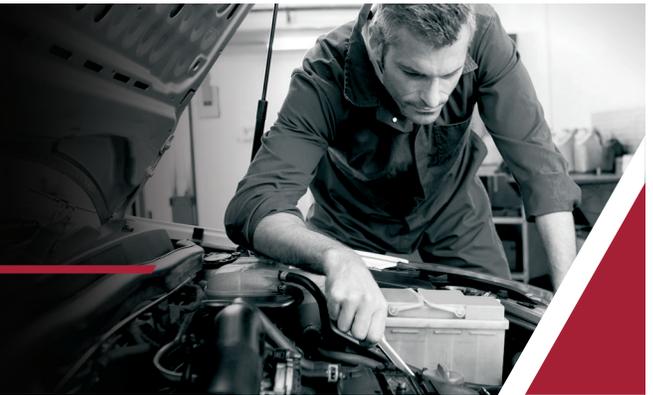
Problem After replacing the Power Steering Pump or steering unit, leaks develop at fittings.

Cause Original O-rings were not replaced, damaged or not properly installed.

Solution Install all supplied O-ring seals as per installation instructions. Be sure to replace the seal inside the pressure hose.

Note Slide pressure hose fitting back and remove old seal. Soften new seal in warm water, expand over a tapered punch, then transfer to hose as shown.
