CARDONE™ ProTech®

Don't Get Power Cylinder or Control Valve Hoses Crossed

Application All linkage-type Power Steering Systems

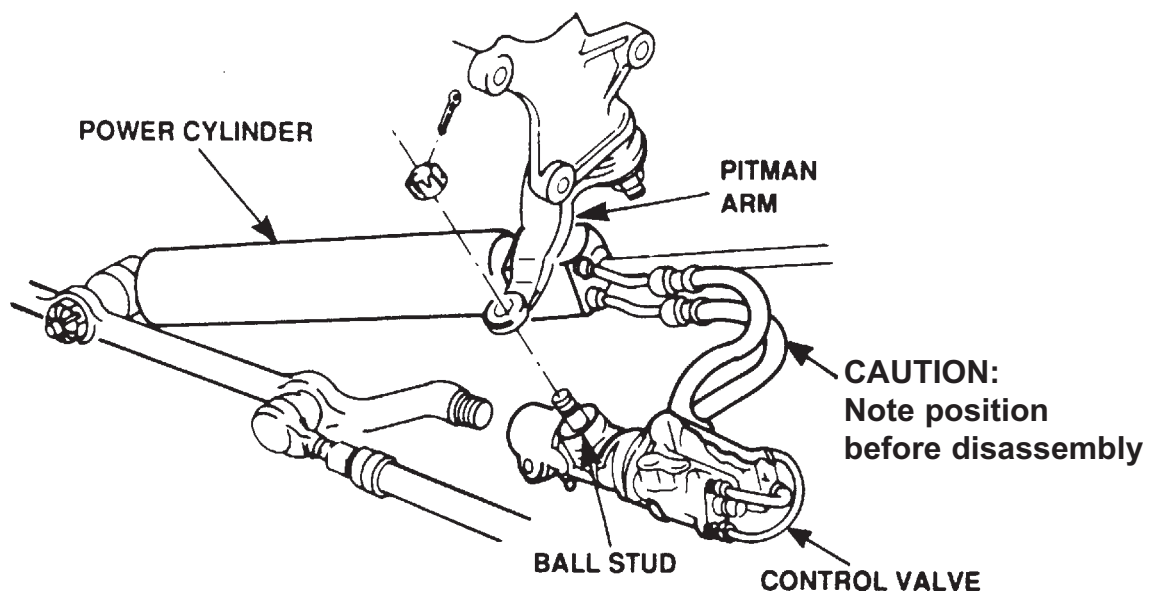
Problem After replacing the power steering unit, the vehicle steers violently from side to side by itself.

Solution When installing a control valve or power cylinder, be extremely careful not to cross the pressure lines to the cylinder. Failure to do so can lead to a malfunction and could result in bodily injury and VOID WARRANTY.

Caution When replacing any part in the power steering system, ALWAYS FLUSH THE SYSTEM USING APPROVED POWER STEERING FLUID AND REPLACE HOSES! New parts can become contaminated with residues from existing components possibly causing malfunctions.
