Chrysler CV ID Guide

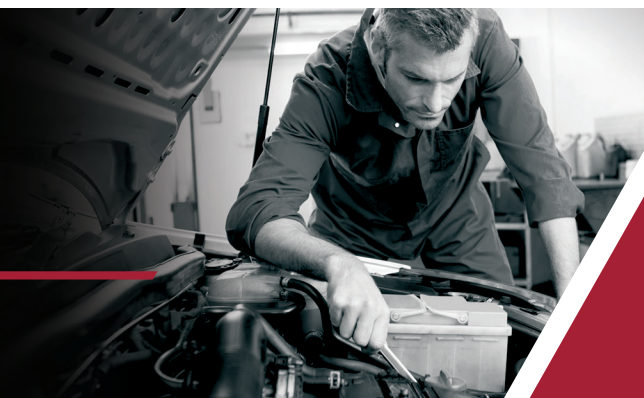
Application	Chrysler front wheel drive axles.
Problem	CV driveaxle replacement units are different.
Cause	Chrysler uses four different design joints.
Solution	All four designs are interchangeable as long as the complete axle is installed.

Note Chrysler CV axles MUST be handled with extreme caution! The inboard joint is spring loaded and may pop loose, causing a total malfunction and VOID THE WARRANTY.
