CARDONE[™] ProTech[®]

Determining GM CV Overall Length

Application GM cars and trucks with Hytrel (Thermo Plastic Elastomer) inner joint boots.

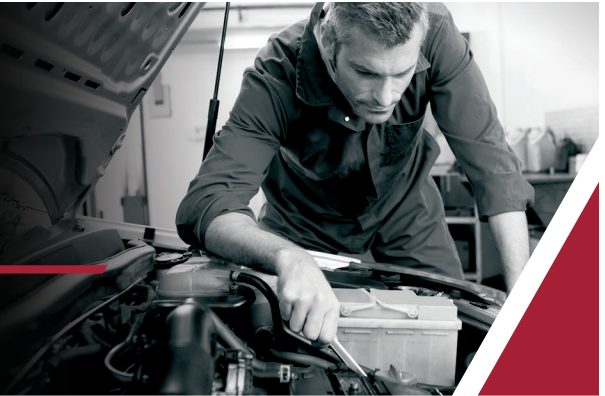
Problem The compressed length of the replacement CV does not match the original unit.

Cause Most GM CV inner boots are made of Hytrel – a hard thermoplastic material. This boot is very stiff and does not allow for boot expansion while compressing the axle. CARDONE CV boots are made of a flexible high quality neoprene that meets SAE specifications. This boot type expands when the axle is compressed due to trapped air, allowing the axle to be fully compressed, while the GM boot does not.

Solution If the original core is not going to be installed back into the car, puncture the inner joint boot so the trapped air can escape. If axle is to be reinstalled, remove the large boot clamp that seals the boot onto the joint and slide back the boot. Now both units can be fully compressed to compare lengths.

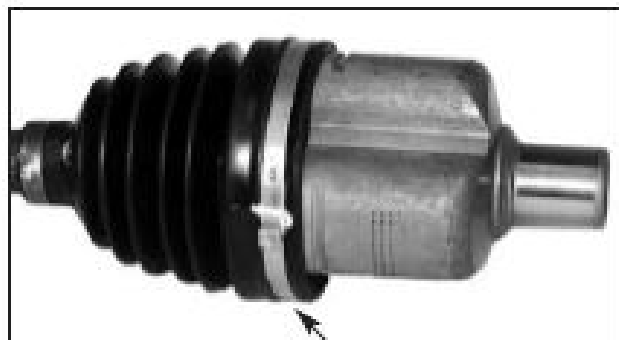
Loosen this clamp
