Different Number of ECC Pins – Problem or Not?

Application Engine Control Computers.

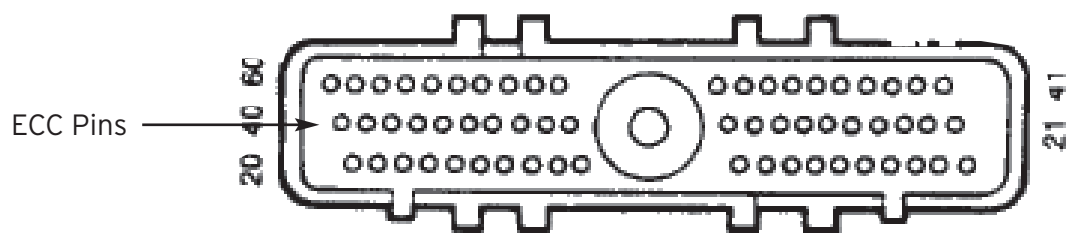
Typical ECC Connector

Solution Don't waste time wrestling with the problem. Always match the original computer service number to the CARDONE part number in the back of the catalog. If correct, the replacement unit will fit and function for the listed application.
