# OVERDRIVE TRANSMISSION KICKDOWN BRACKET P/N 20-121

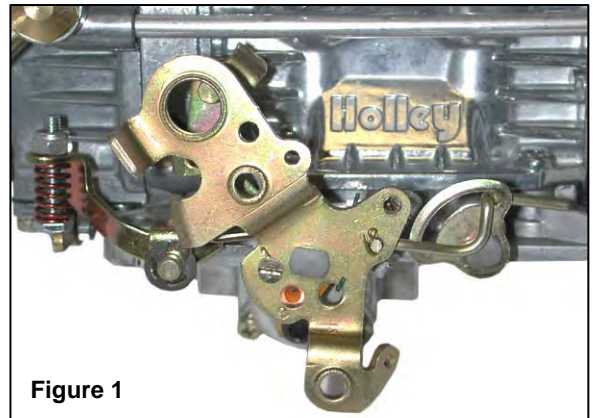
Figure 1

Thank you for purchasing the Holley® 20-121 Overdrive Transmission Kickdown Bracket. This bracket is designed for use with Holley® carburetors controlling GM 200R4 and 700R4 transmissions utilizing the throttle lever style shown in **Figure 1**.

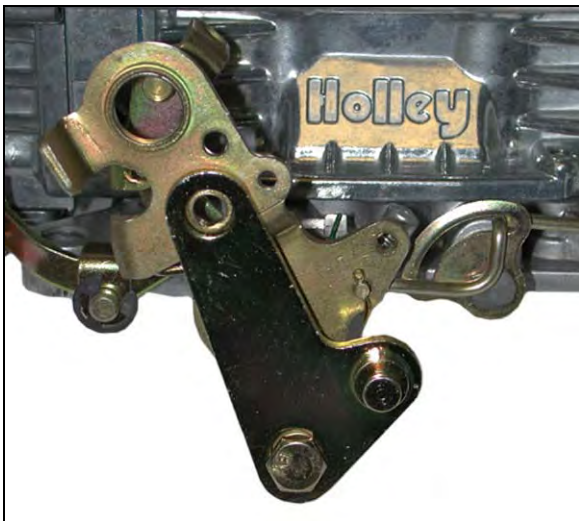
Figure 2

3. Install the Holley® kickdown bracket with the stud facing away from the carburetor and towards the rear, as shown in **Figure 2**. Line up the slotted hole with the lower hole in the carburetor throttle lever. Loosely install the bolt, nut, and washer.

4. Line up the upper hole in the Holley® kickdown bracket with the small upper hole in the carburetor throttle lever. Install a throttle cable stud or throttle cable ball that matches your cable end and tighten securely. An additional bolt, nut, and washer is provided to secure the upper end of the bracket, in case your vehicle utilizes the larger 1/2" diameter hole for the throttle cable stud.
