# HOW TO TEST BALL JOINTS FOR MOVEMENT

## Dodge Ram Trucks and Jeep SUVs

## Telescoping Upper Ball Joint Inspection Procedure

## Compression-Loaded Front Lower Ball Joint Inspection Procedure

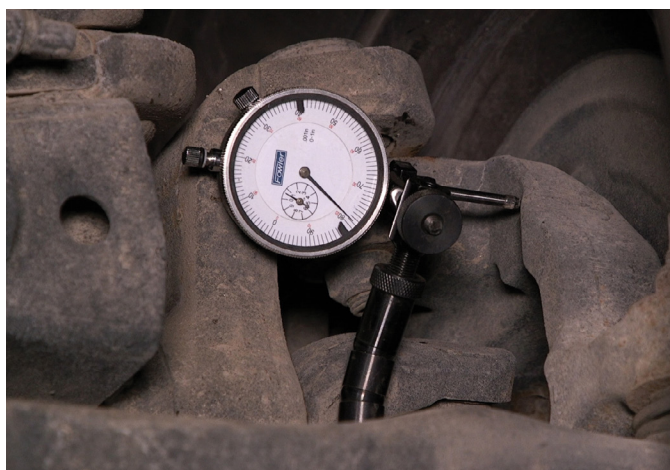
**Step 2** – Attach dial indicator.

- Rest dial on either the front or the back of the steering knuckle.
- Put dial as close to the upper ball joint as possible.

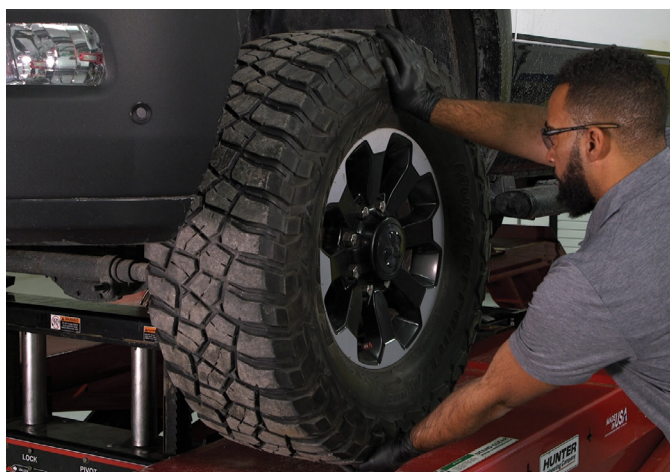
**Step 4** – Get first reading.

- Push in the top of the tire and pull out on the bottom of the tire. Write down the reading on the dial indicator.

- Get the total upper ball joint movement by adding the two readings together. If the total is above 1.52mm (0.060"), then replace the upper ball joint.

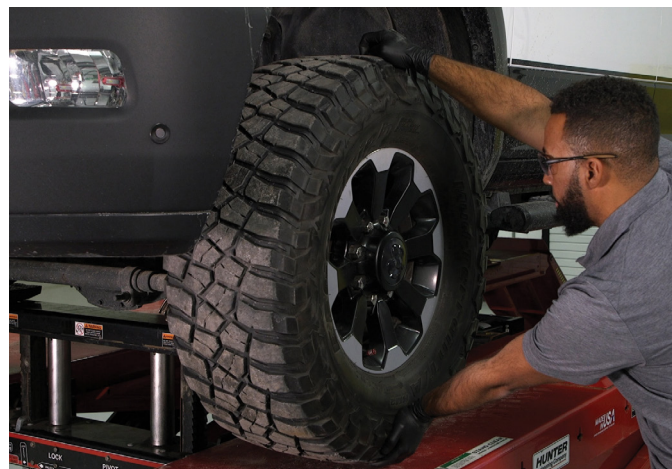
**Step 6** – Get second reading.

- Pull out on the top of the tire and push in on the bottom of the tire. Write down the reading on the dial indicator.

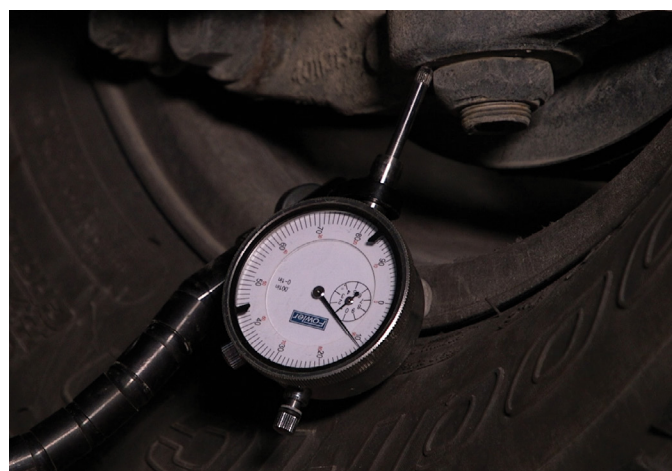
**Step 2** – Attach the dial indicator.

- Place the dial indicator on the flat part of the steering knuckle by the lower ball stud.

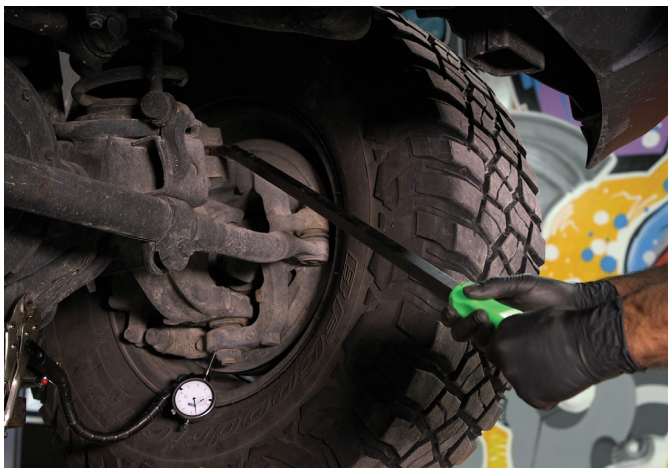
**Step 4** – Get first reading.

- Apply pressure using a pry bar between the knuckle and the axle tube yoke. Write down the reading on the dial indicator.
- *Helpful hint: Be careful not to damage the upper ball joint grease seal.*

- Get the total lower ball joint movement by adding the two readings together. If the total is above 2.29mm (0.090"), then replace the lower ball joint.

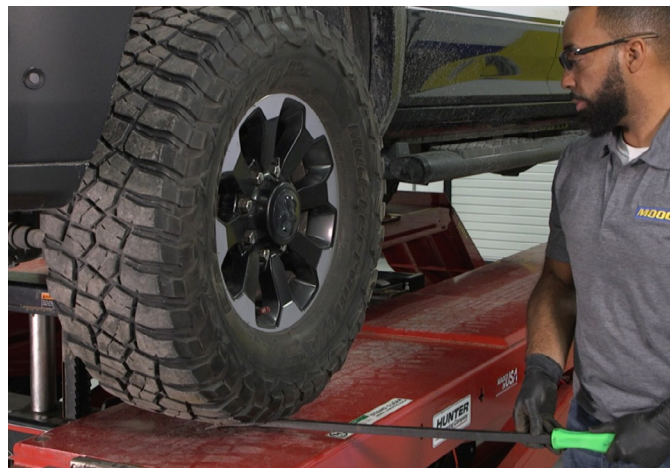
**Step 6** – Get second reading.

- Use a long pry bar (similar size to image at right), pry under the front tire near the ball joint. Write down the reading on the dial indicator.
- *Helpful hint: Only use enough force to overcome the weight of the rotor and knuckle. Excessive force could cause damage or false readings.*
