# DORMAN HEATER HOSE ASSEMBLIES

## FEATURED SOLUTIONS

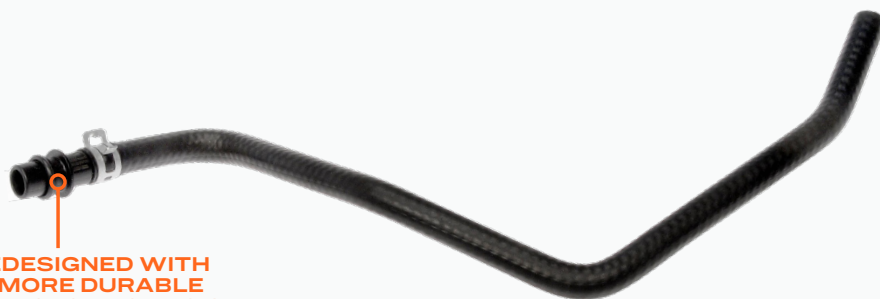
**626-609**  
Chevrolet Cruze 2016-11,  
Chevrolet Cruze Limited 2016

REDESIGNED WITH  
A MORE DURABLE  
CONNECTOR TO RESIST  
CRACKING AND LEAKING

**PROBLEM:**  
Brittle factory connector  
cracks and leaks over time.

**FIX:**  
Redesigned mating  
connector provides a  
more secure connection  
to the water outlet for  
a longer service life

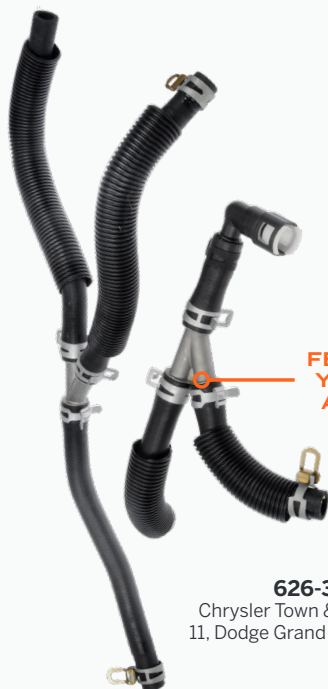
**626-315HP**  
Chrysler Town & Country 2016-  
11, Dodge Grand Caravan 2020-11

FEATURES ALUMINUM  
Y-CONNECTORS FOR  
ADDED DURABILITY

**PROBLEM:**  
Original equipment HVAC  
heater hose assemblies  
often fail due to cracks in  
the plastic Y-connector.

**FIX:**  
These Dorman OE FIX  
replacements feature  
upgraded aluminum  
Y-connectors to prevent  
similar failures in the future.
